OUSE BURN

Restoration, flood retention and enhancement opportunities
and examples

the Environment Agency

March 2015

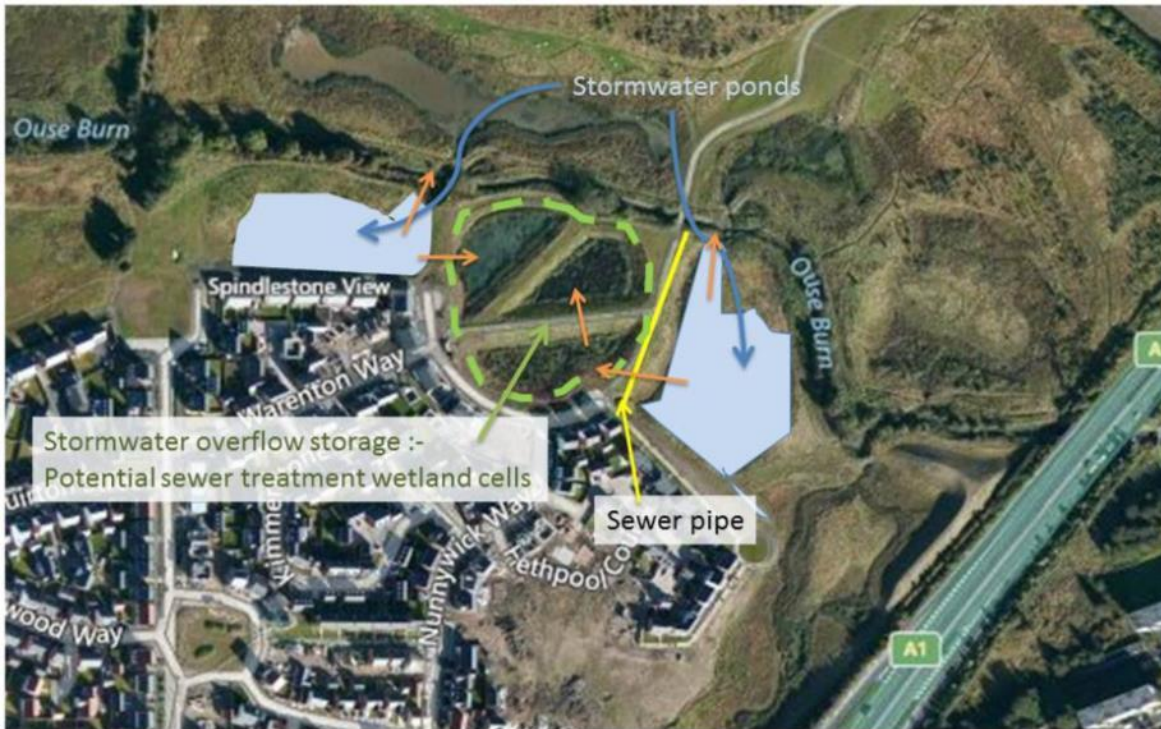
Figure 1. Diversion of the Kingston Park outfall to the storm water overflow

Whilst it is recognised that previous reports have indicated that reconfiguring the existing sewer pipe could be extremely costly, it is recommended that alternative options are considered. There could be an opportunity to block the existing pipe and divert the outfall to the storm water overflow area as indicated in the diagram below (Figure 1). This could then act as a treatment pond for the contamination before entering the watercourse. Potentially this would a significant positive impact on the water course.

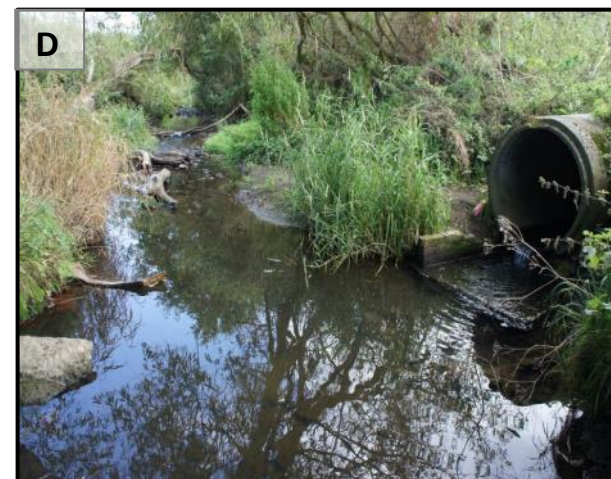
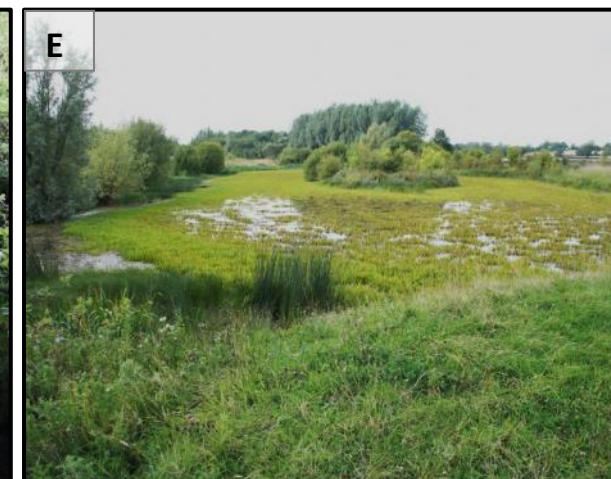
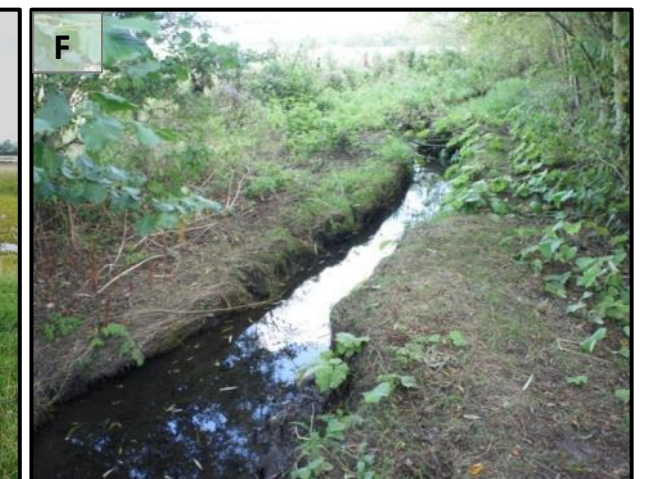
Section 2 – Callerton ponds west of A696. Google (Imagery ©2014 Bluesky, Digital Globe, Getmapping plc, Infoterra Ltd & Bluesky, The GeoInformation Group, Landsat, Map data ©2014 Google)

- Reconnecting to floodplain – Bio, HM, NFM (H)
- Reedbed at outfall – HM, WQ, Bio (S)
- Tributary – Bio, HM, NFM (L)
- Improve eastern fishing pond – SAE (L)

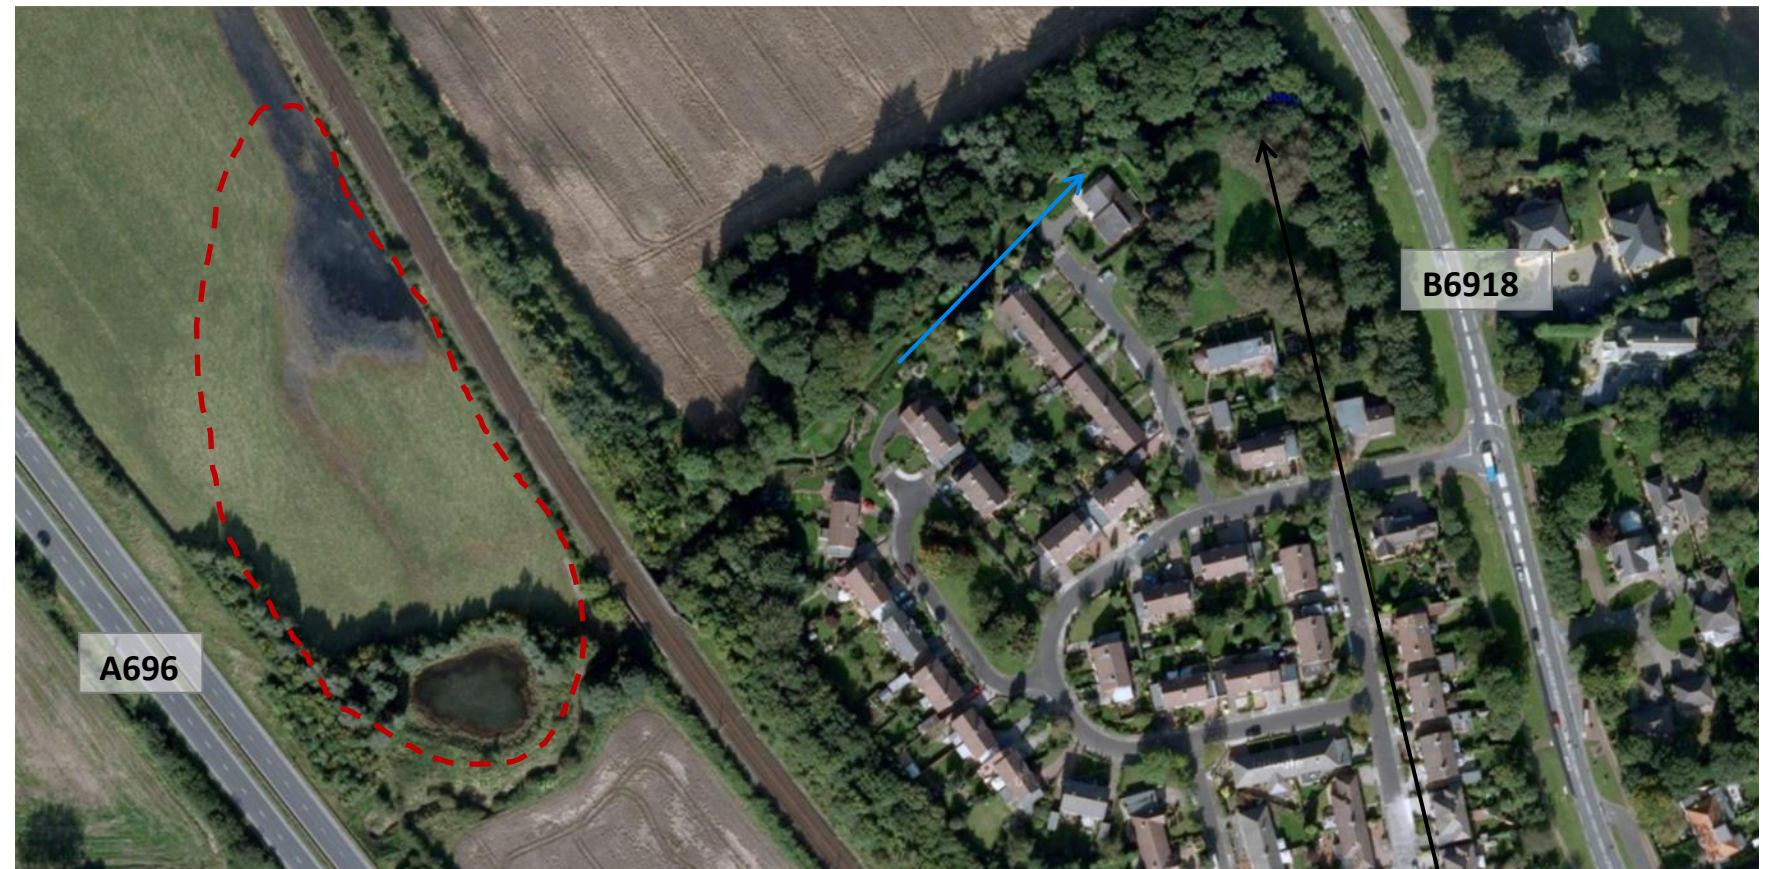
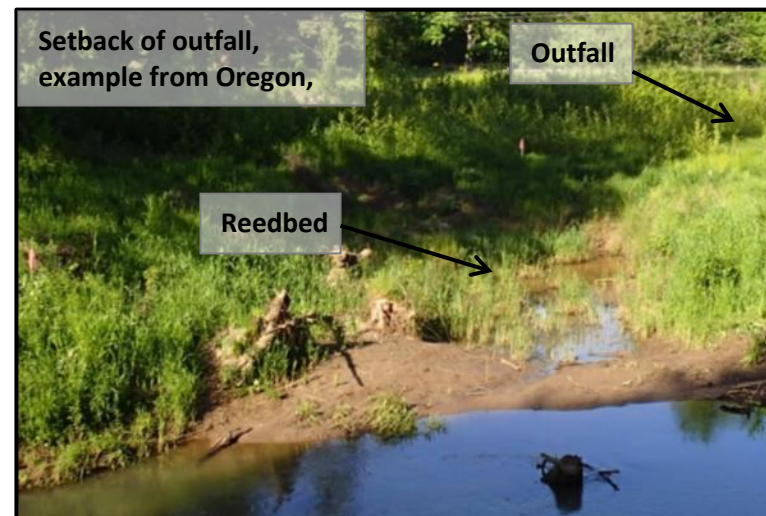
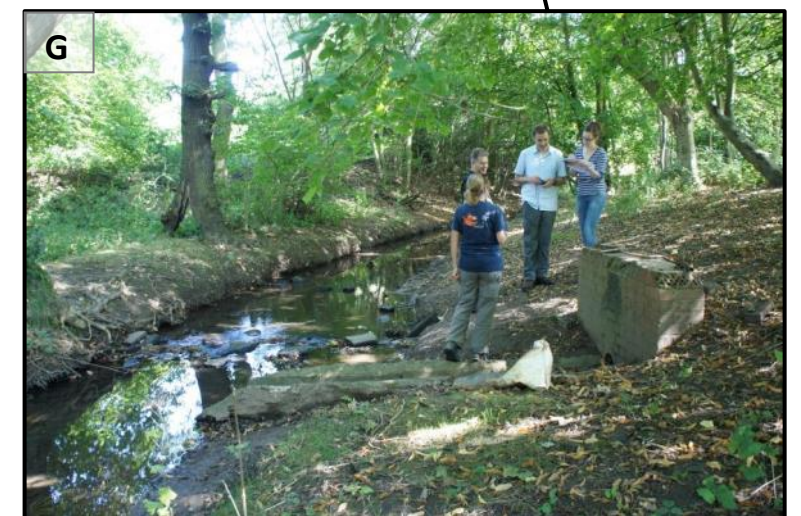
Section 3 – Woosington, east of A696. Google (Imagery ©2014 Bluesky, Digital Globe, Getmapping plc, Infoterra Ltd & Bluesky, The GeoInformation Group, Landsat, Map data ©2014 Google)

- Water quality issues, suspected runoff from road (A696) entering the river.
- Outfall in Woosington seems to be carrying silt and possibly pollutants (photo G).
- River silty with poor instream habitat quality. In low flow conditions the river is very shallow.

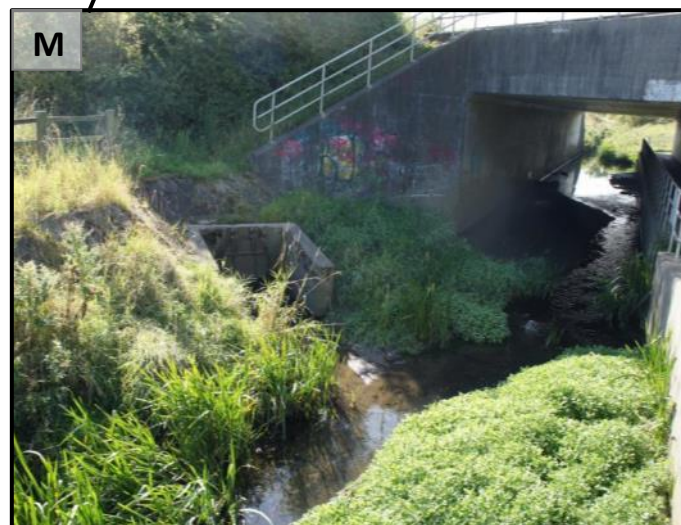
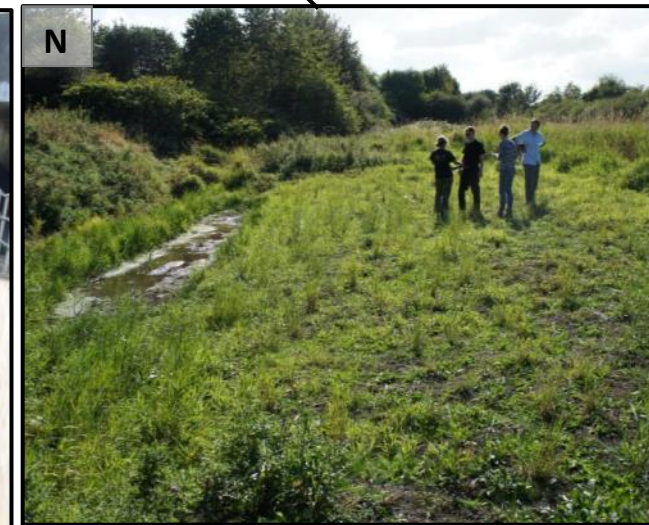
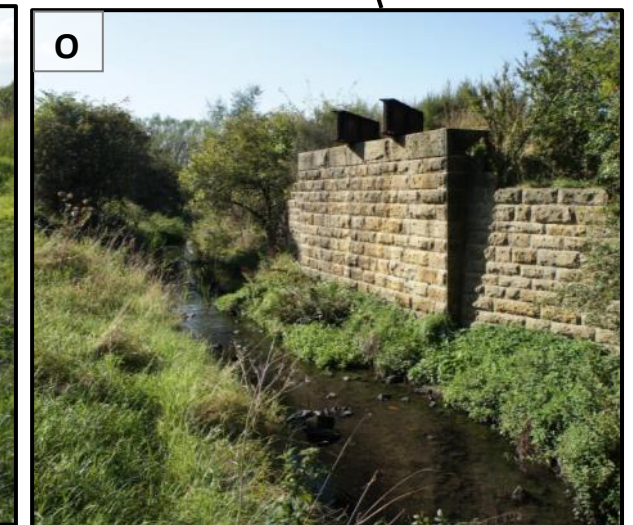
Section 6 – East side of A1. Google (Imagery ©2014 Bluesky, Digital Globe, Getmapping plc, Infoterra Ltd & Bluesky, The GeoInformation Group, Landsat, Map data ©2014 Google)

- Setting back outfall – WQ, FRM, Bio, HM, SAE (H)
- New/improved SuDS – WQ, FRM, Bio (M)
- Instream/riparian improvements – Bio, HM, SAE (M)

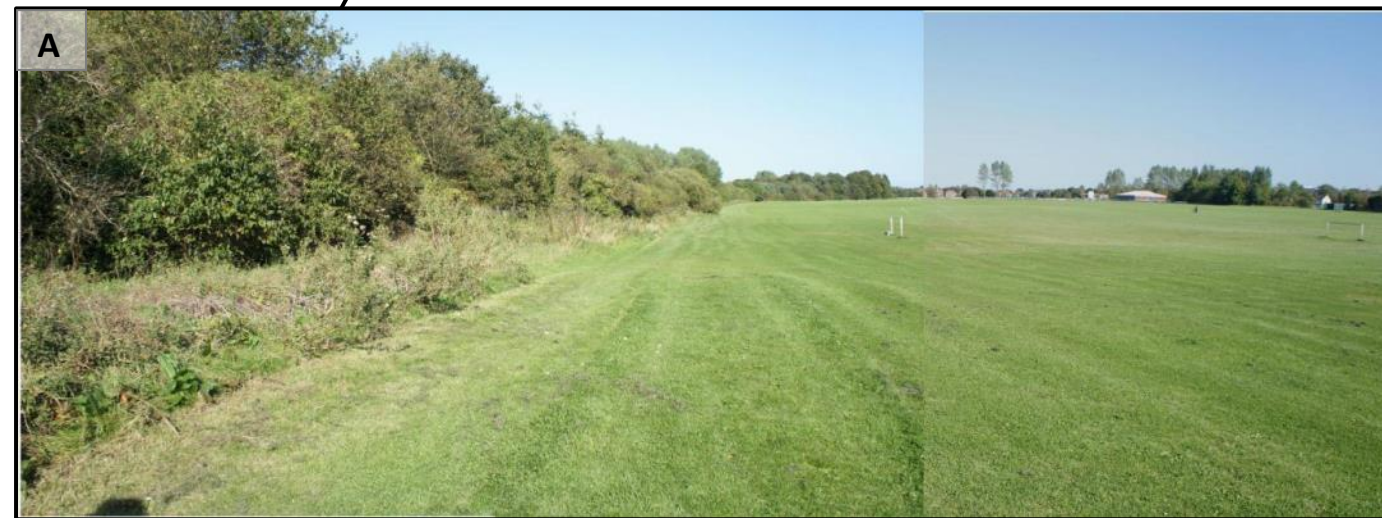
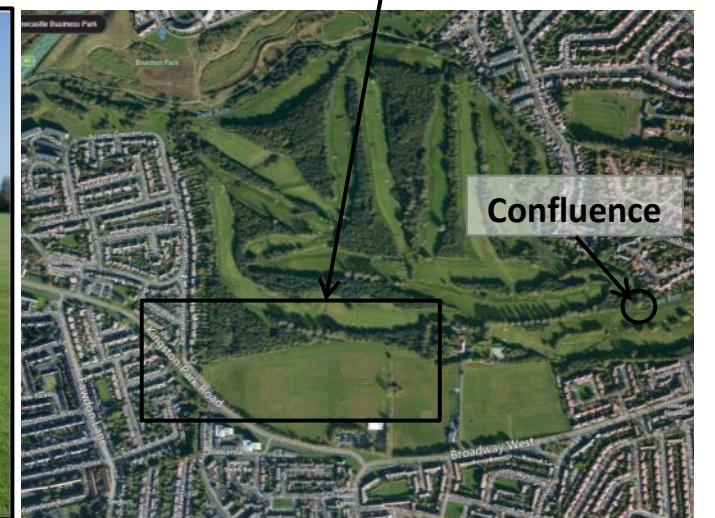
Section 7 – Tributary along playing field. Google (Imagery ©2014 Bluesky, Digital Globe, Getmapping plc, Infoterris Ltd & Bluesky, The GeoInformation Group, Landsat, Map data ©2014 Google)

- Expanding the watercourse corridor, re-profiling and adding instream diversity – FRM, Bio, SAE (M)
- Moving pitches and engaging with local community – SAE (S)

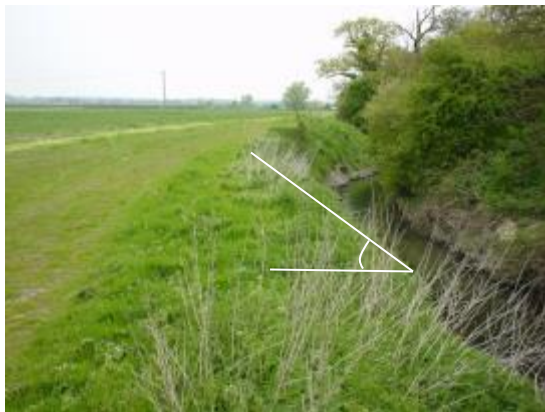
Before, May 2001

Steep angle of the bank before re-profiling carried out.

Nettle banks with dredgings levee.

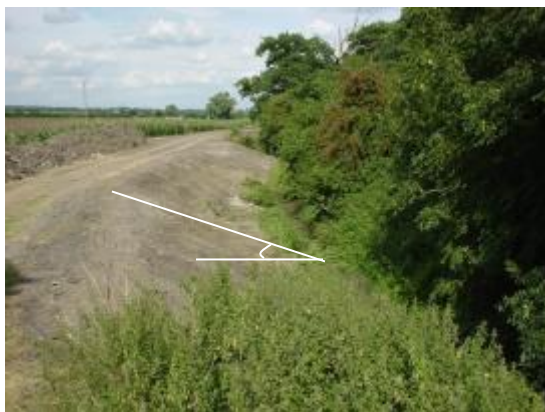
During, August 2002

Re-profiling results in a shallower bank angle and top of bank set back.

Nutrient rich dredgings and topsoil removed and piled behind track waiting to be spread. Ledge formed by pushing toe forward – vegetation and roots intact.

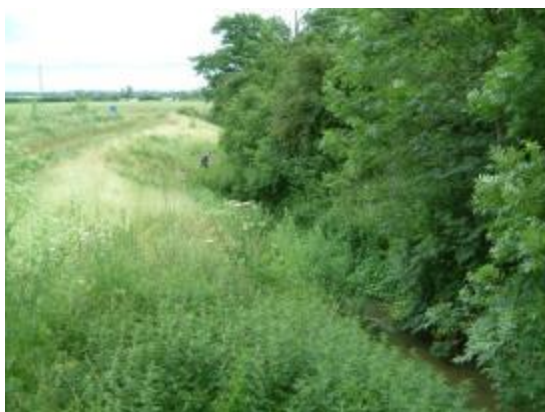
After, June 2003

Bank grass seeding established.

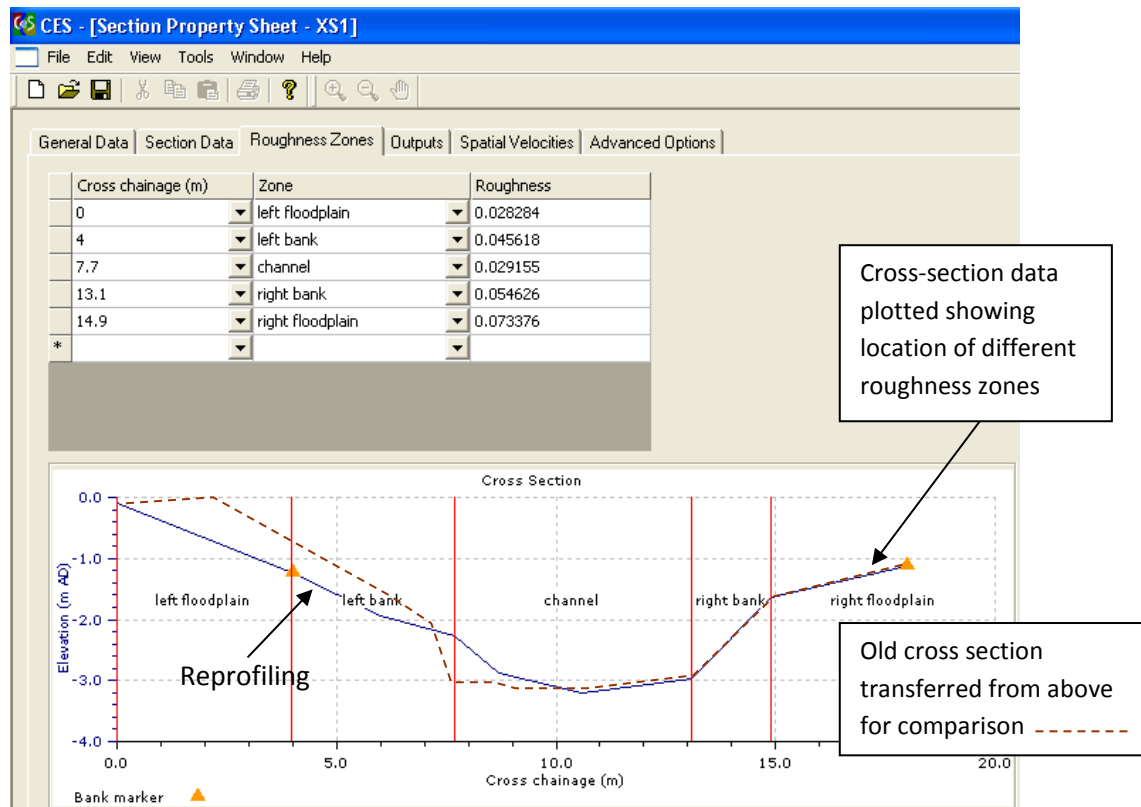
Figure 2. River Rhee cross section 1, pre and post works.

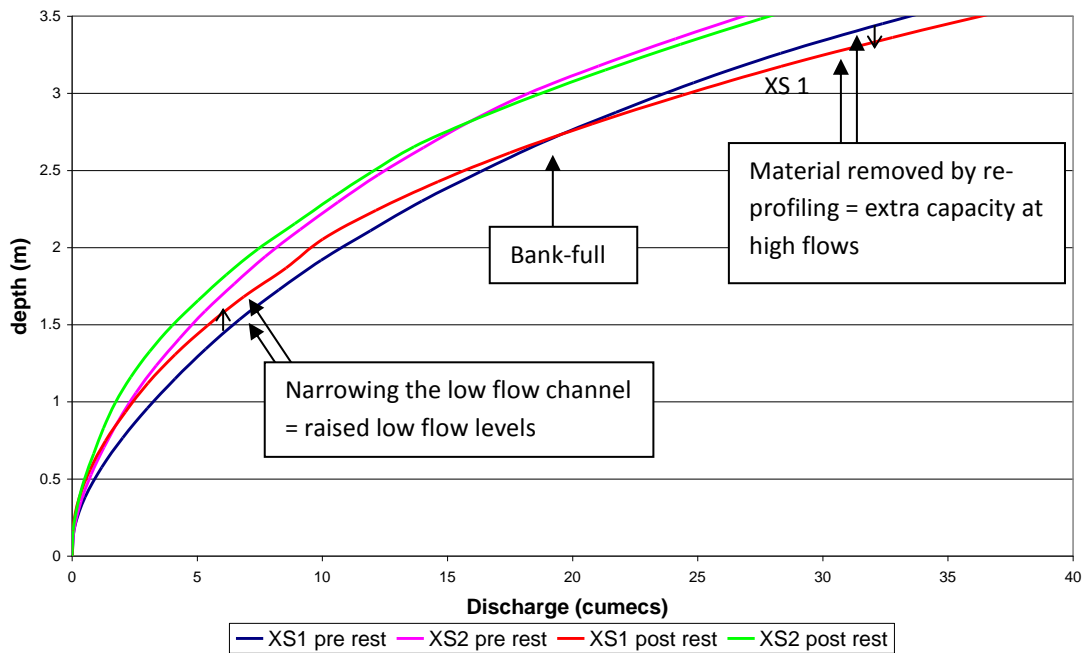
Figure 3. Stage discharge curve for the River Rhee cross sections.

Figure 3 shows that up to the bank-full level, the post restoration channel has a greater depth for the same discharge which is to be expected as the section is being narrowed.

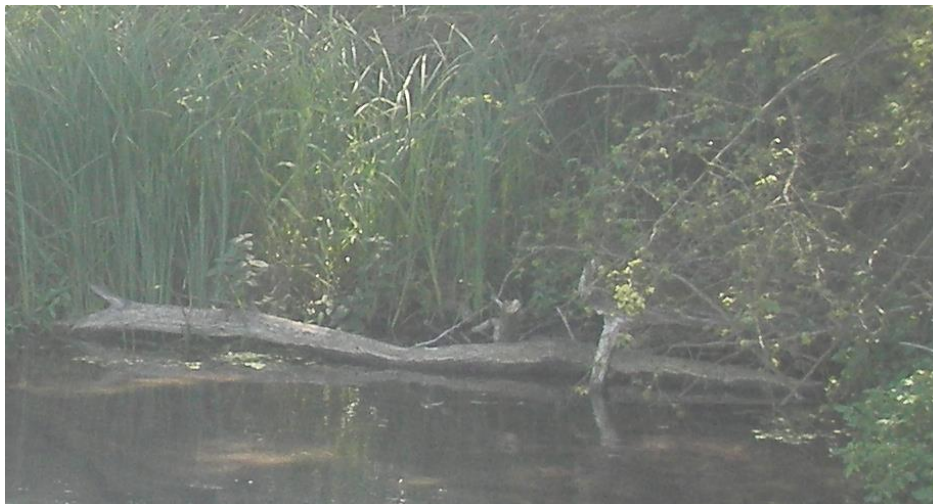
NOTE: As shown in diagram below think carefully about whether deflectors are facing up or downstream.

Example of the use of woody debris – note dimensions and level would need to be adapted for the specific site

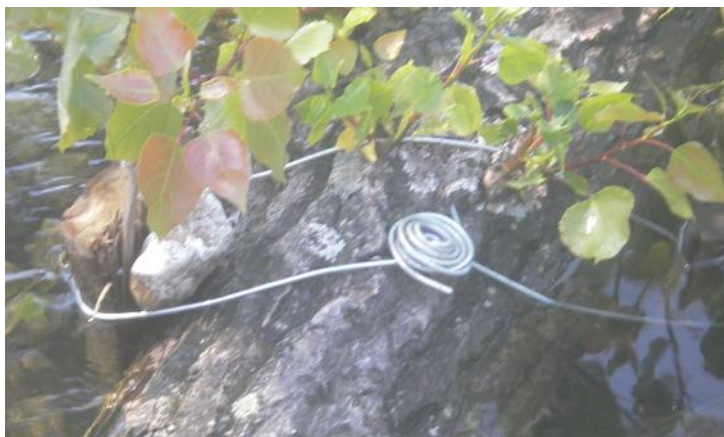
Example 1 of staking in wood

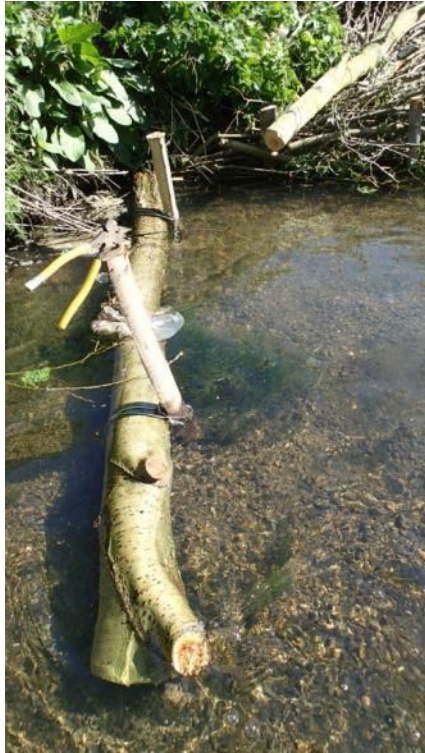
Example 2 of staking in wood

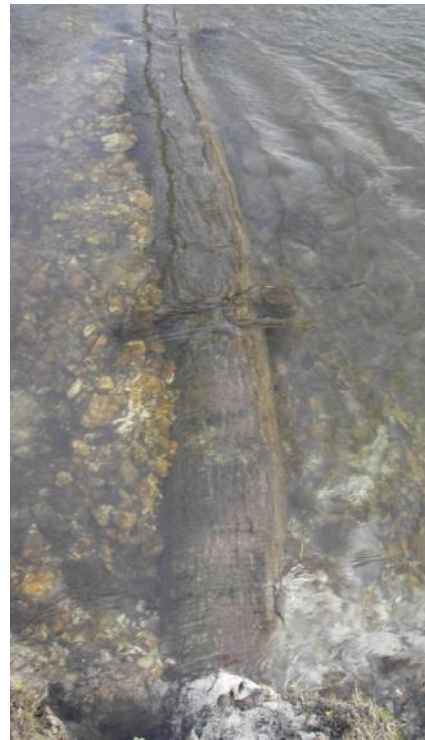
Staked-in wood showing impact on bed morphology locally and flow characteristics

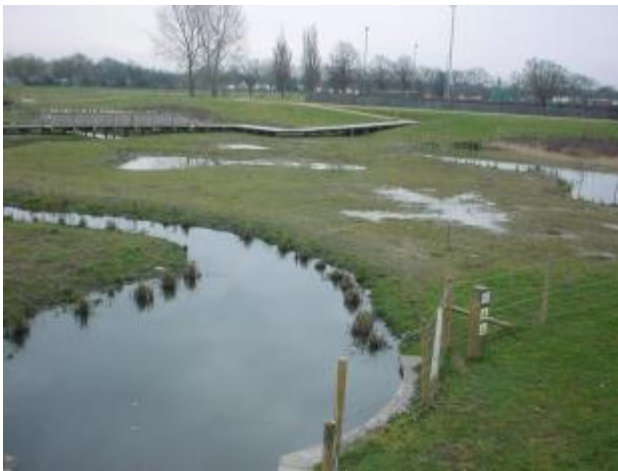
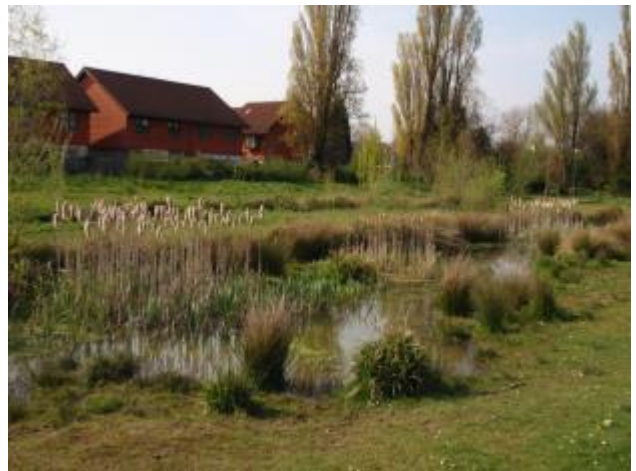
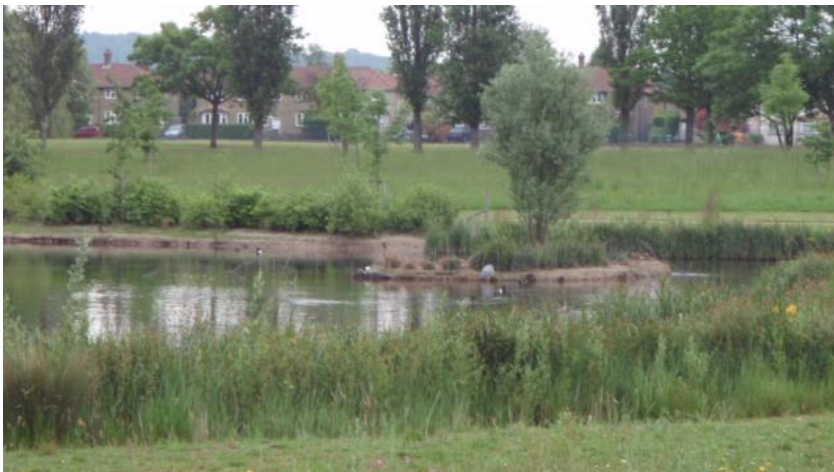
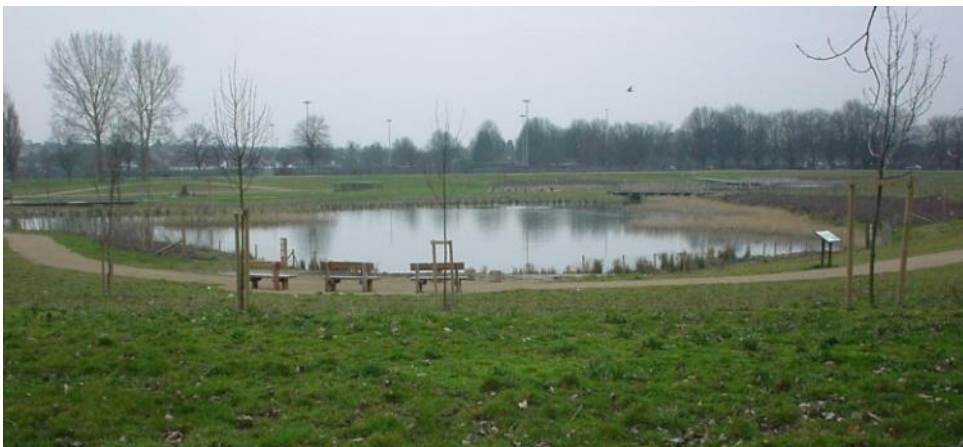
Appendix C – Wetlands, ponds and scrapes, case study: River Quaggy in London

Along the Ouseburn opportunities have been identified where a mixture of ponds and scrapes could be included as design features in the floodplain. Creating ponds and scrapes at different depths provide for a range of habitats (both permanent and semi-permanent) as well as being able to store water on the floodplain. The River Quaggy at Sutcliffe Park and Chinbrook Meadows, near Lewisham, London, provide good examples of what can be achieved as part of a river restoration scheme. Both projects provide additional flood storage areas whilst also creating attractive open spaces for the public. As well as lowering and reshaping the floodplain areas to store flood waters, a range of habitat features were created that included more traditional ponds through to small scrapes. Networks of boardwalks, pathways and viewing points were included in the designs.

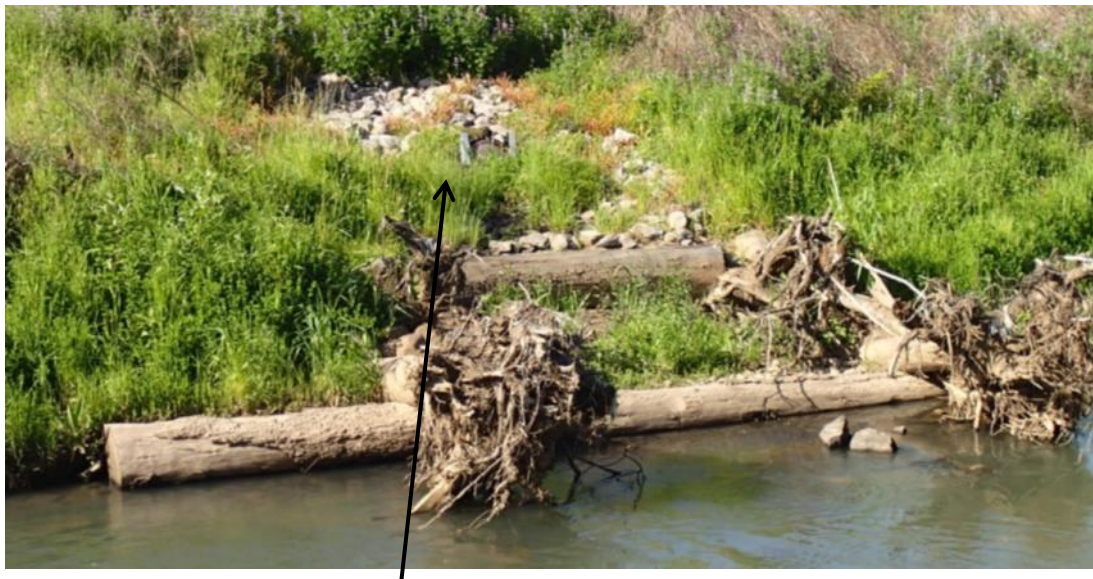
Outfall setback with vegetation, gravel and staked in wood for habitat

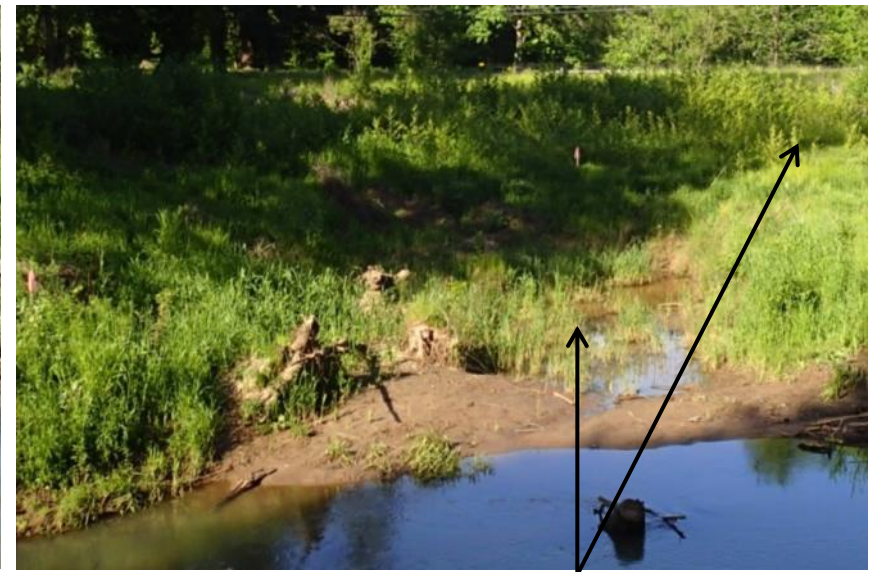
Outfall setback with reeds growing at downstream end near watercourse

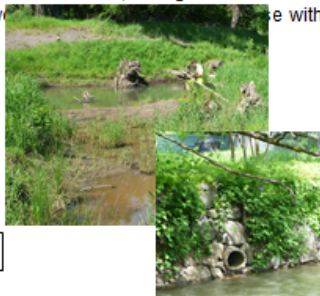
Figure 1: Set-back and direct outfalls within the study catchment.

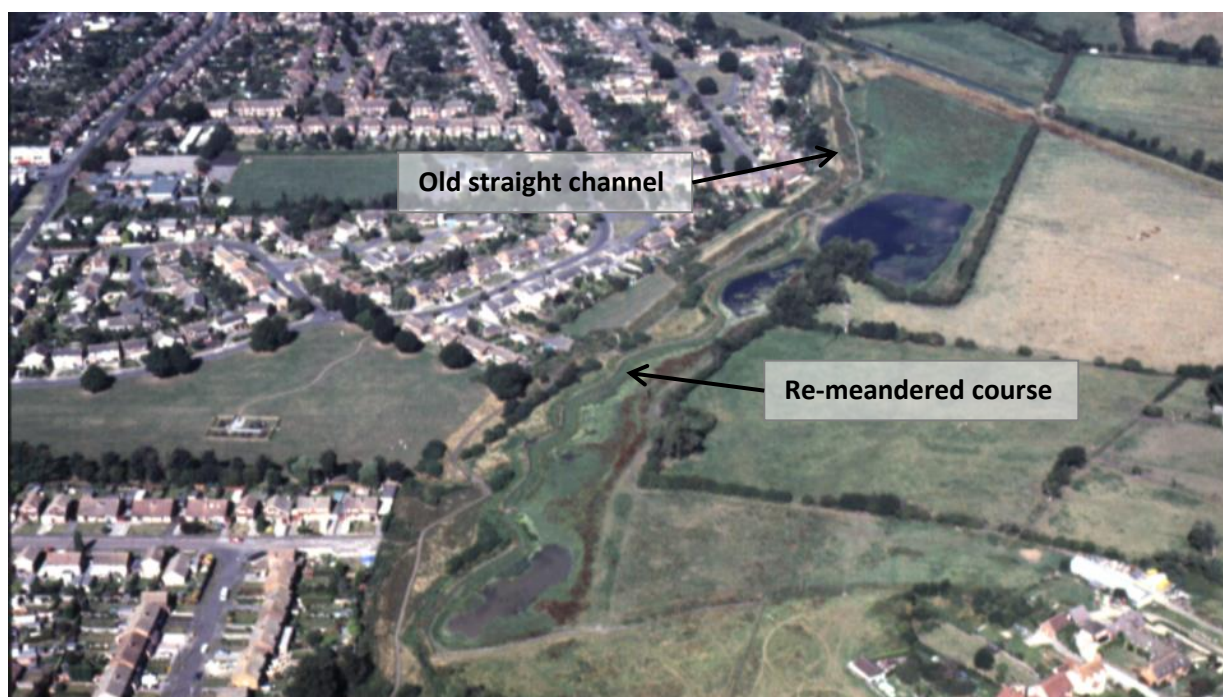
Aerial view of the Brook and flood storage/overspill area

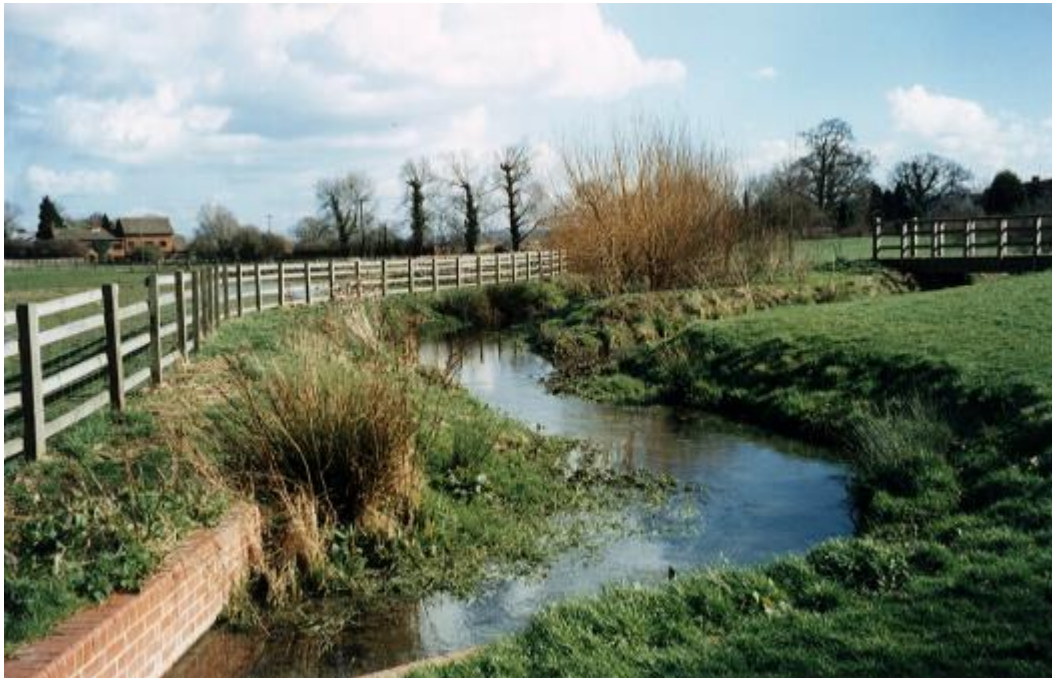
Four years on and vegetation is shaping the low flow channel, establishing in the deposited silty margins

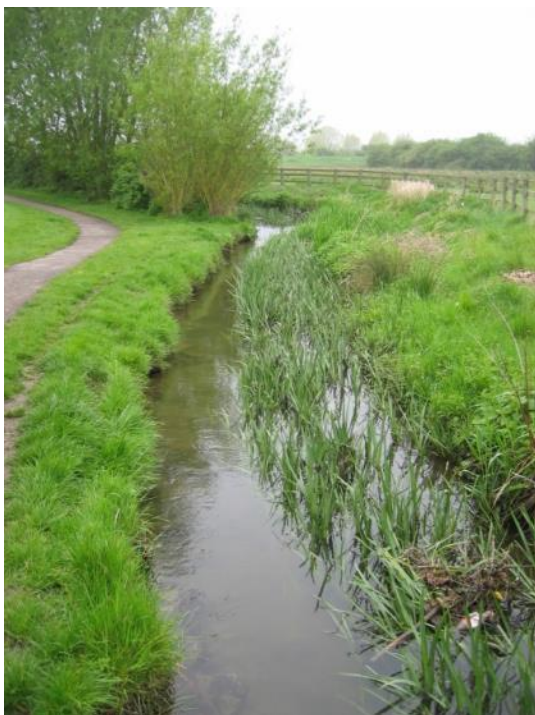
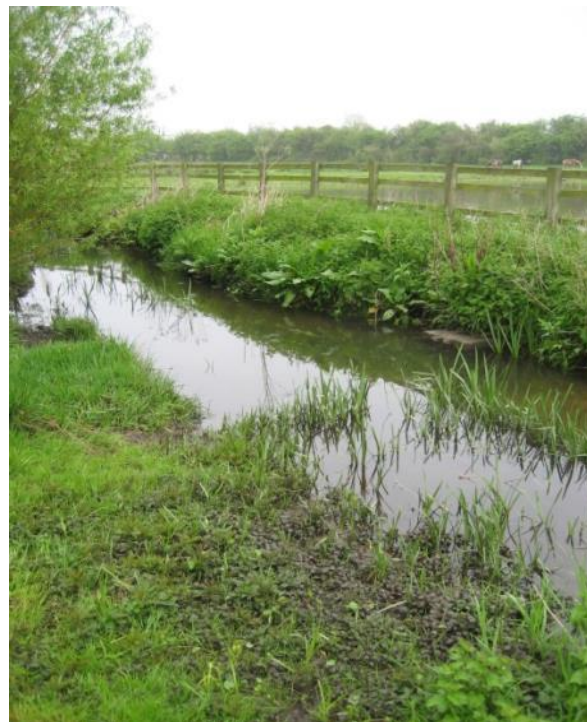
Twelve years on. Marginal plant growth is trapping silt and narrowing the channel to form more flow diversity with clear sediments in the open channel. Very shallow slopes allow greater adjustment and development of different habitat and vegetation types.

Re-visiting the site in 2006, the brook had narrowed by over a metre in places and this has exposed/maintained a clear bed. Where vegetation has not extended out into the channel, silt deposition is still evident, but there is a distinct delineation between clear bed and silt covered bed.
